AEDC-TR-68-23

## **EFFECT OF CONTAMINATION ON SPACECRAFT SURFACES EXPOSED TO ROCKET EXHAUSTS**

**TECHNICAL REPORTS** B. A. Burch  
**FILE COPY** ARO, Inc.

**April 1968**

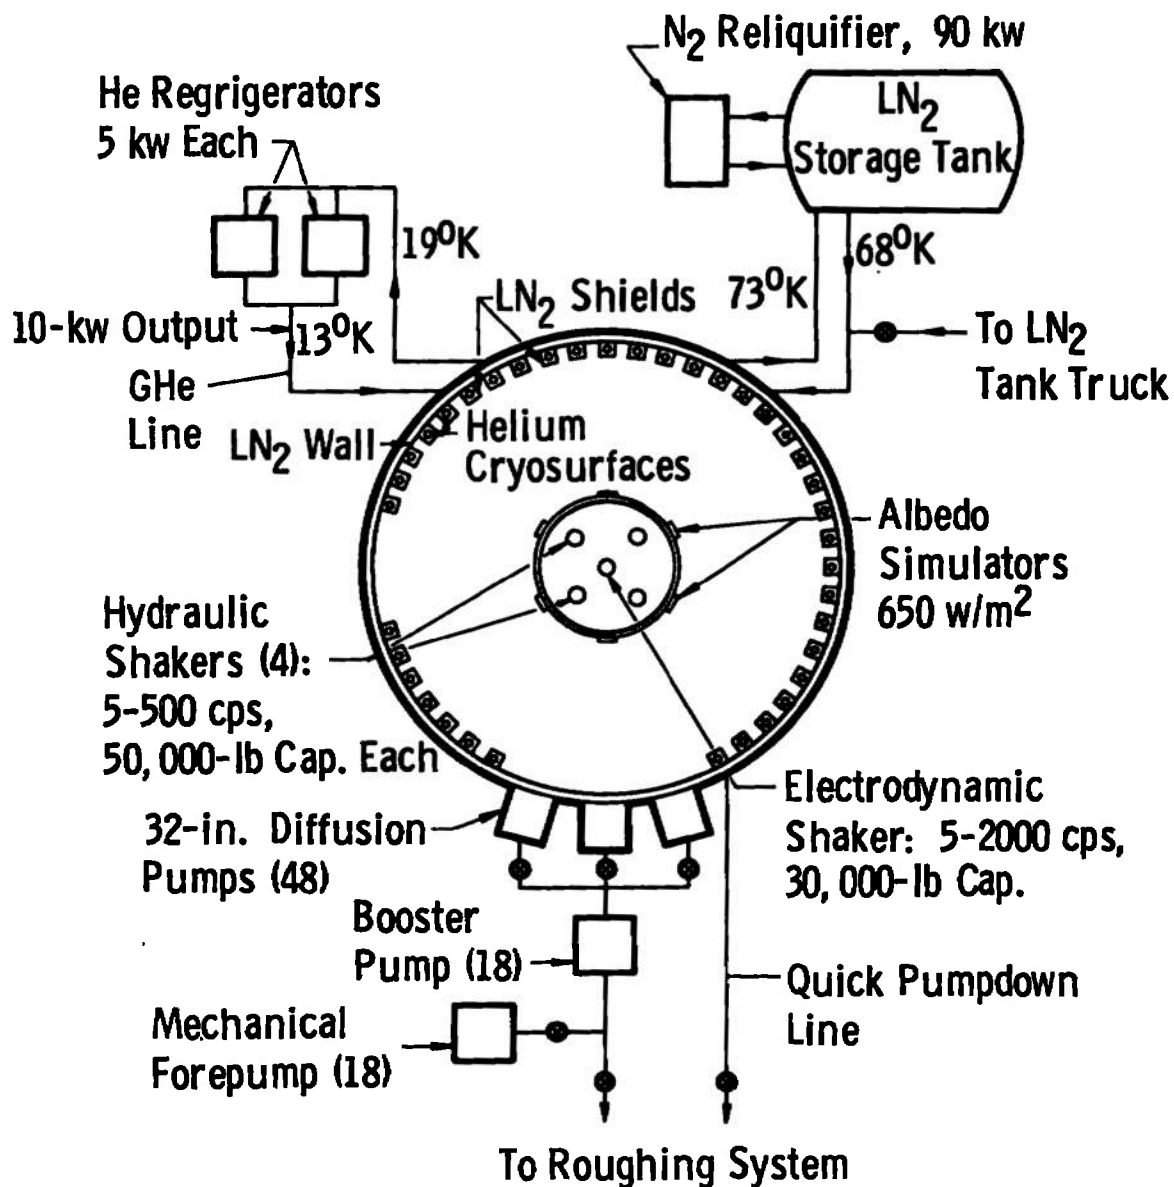
Fig. 1 Mark I Schematic

The Mark I system (Ref. 5) consists of a large cylindrical vacuum tank, pumping systems, thermal environmental systems, vibration system, controls, and instrumentation suitable for conducting tests on large space vehicles. A schematic of the facility is shown in Fig. 1, Appendix I. The chamber and associated equipment areas are shown in Fig. 2.

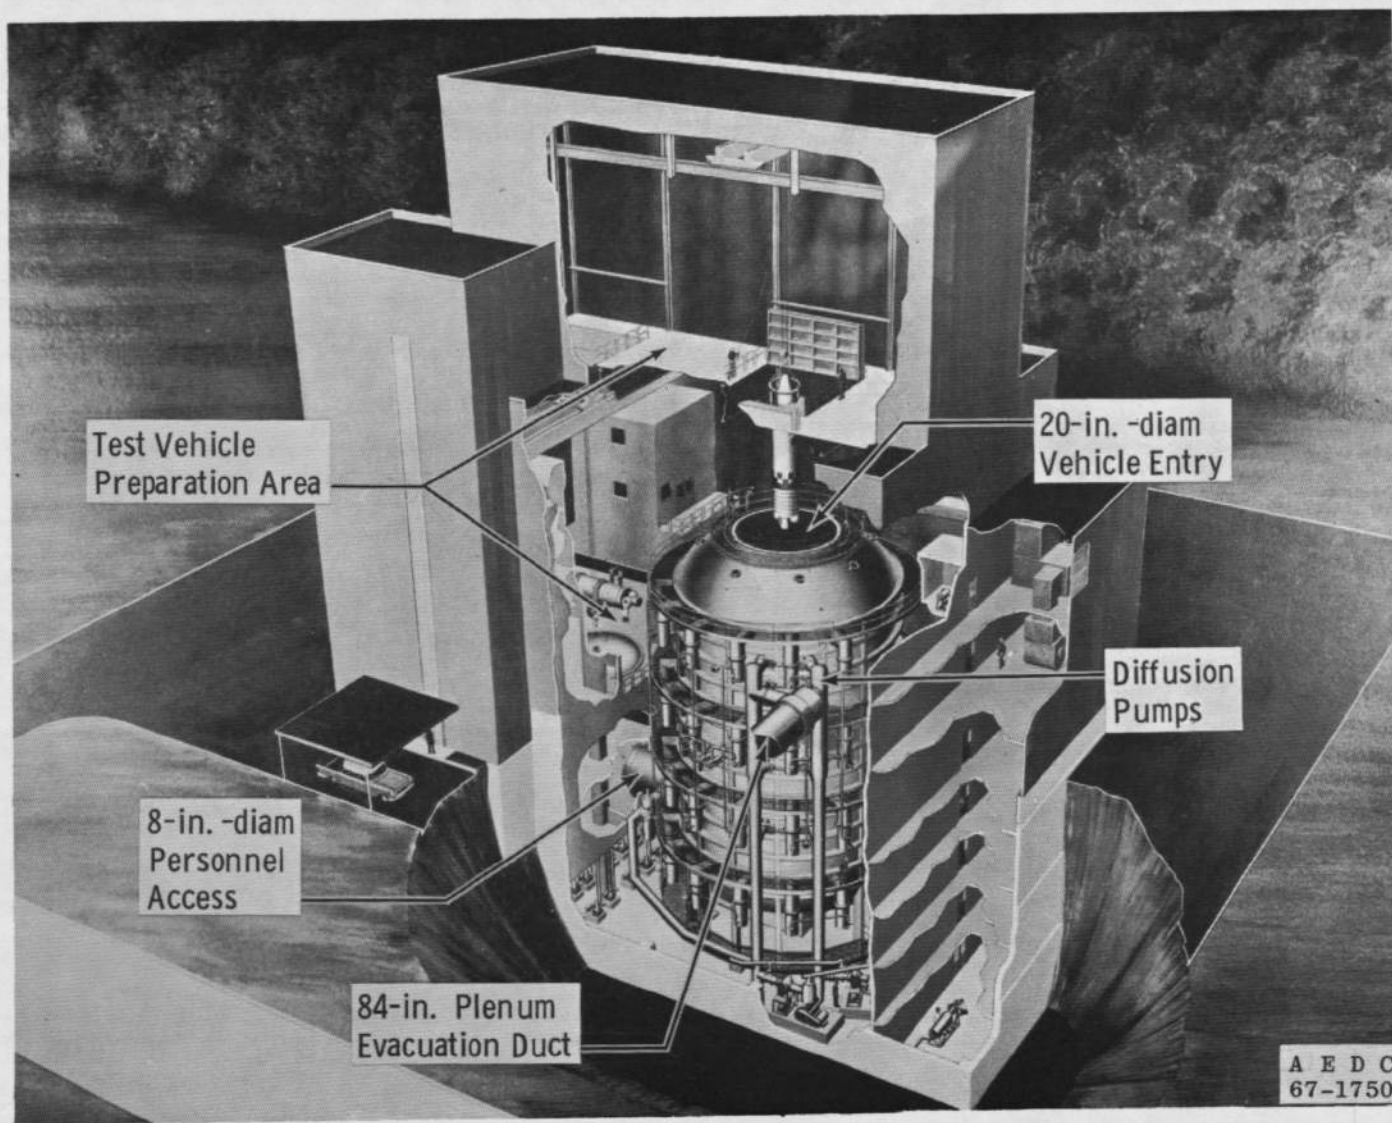
Fig. 2 Mark I Chamber

The Mark I chamber (Fig. 2) is a cylindrical vessel 42 ft in diameter and 82 ft high with 0.875-in.-thick walls and 1.5-in.-thick elliptical heads. The inside working dimensions of the chamber are 35 ft in diameter and 65 ft in height. The chamber shell is constructed of type 304L stainless steel for low outgassing and good corrosion resistance. Vehicle entrance to the chamber is through a 20-ft-diam hatch located in the top of the chamber. Personnel access to the chamber is through a hatch 8 ft in diameter near the bottom of the chamber.

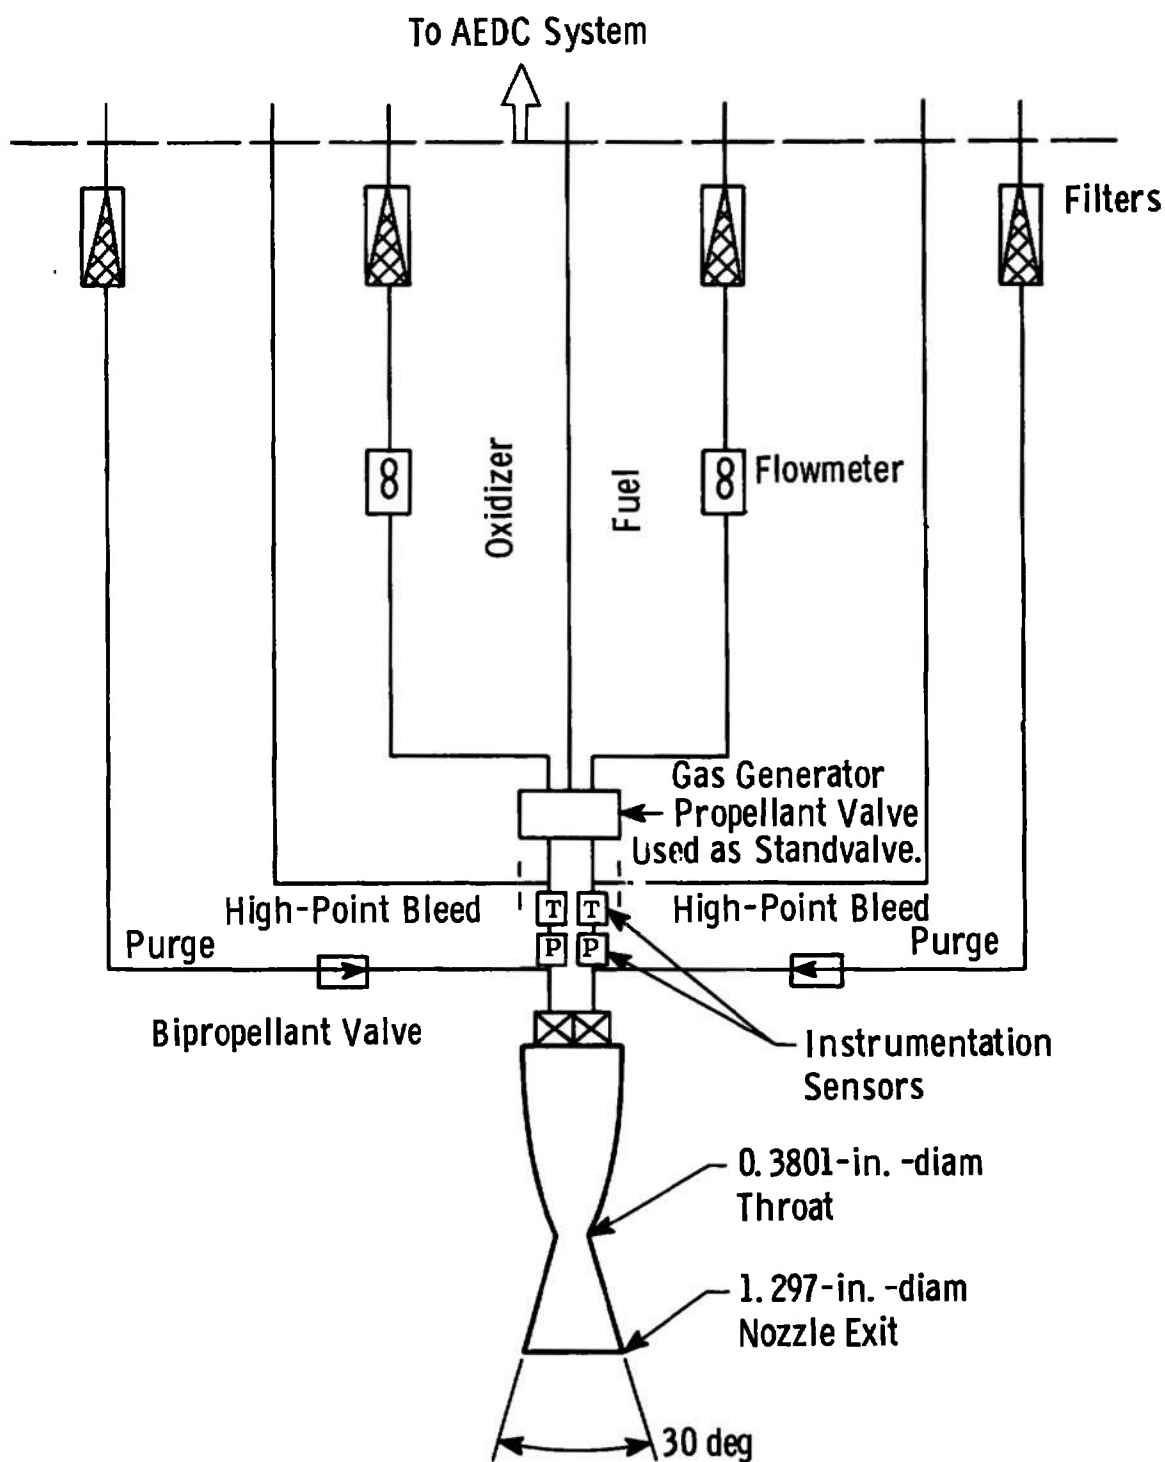
Fig. 3 Rocket Engine Test Module Schematic

Testing was conducted using a 23-lb<sub>f</sub> pitch/yaw engine manufactured by Bell Aerosystem Company. The installation schematic and nozzle dimensions are shown in Fig. 3.

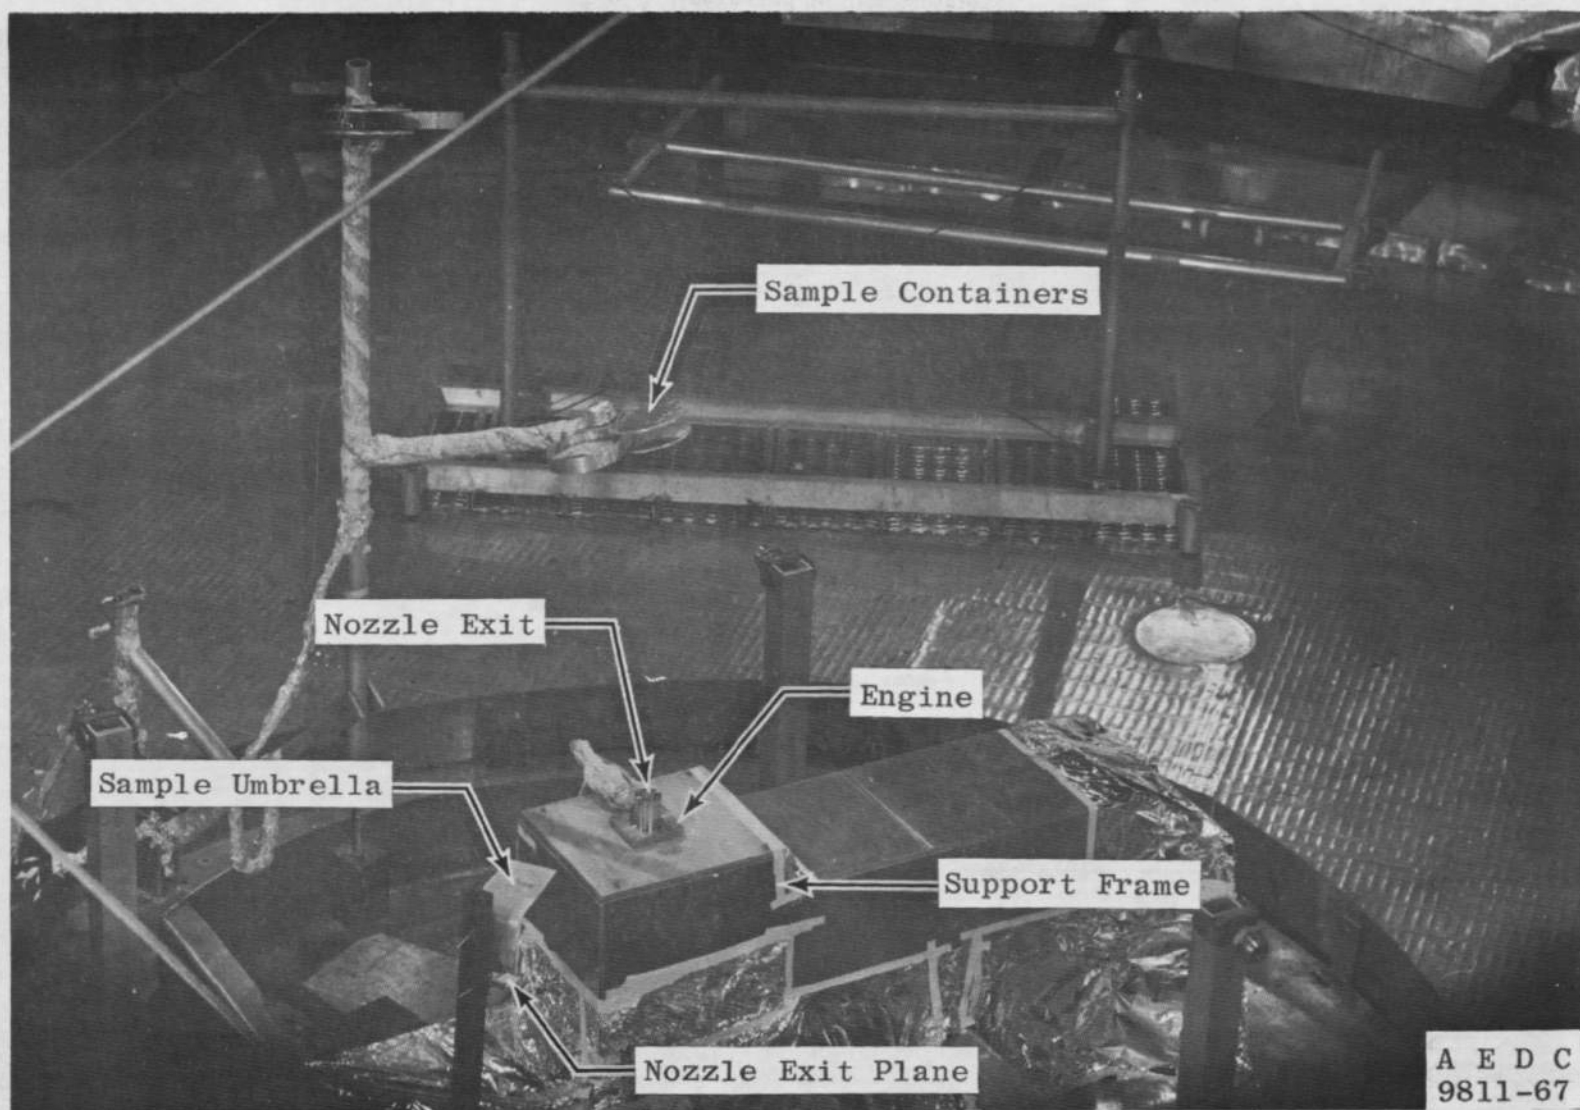
Fig. 4 Test Installation

The engine was mounted in a supporting frame located on the chamber floor (Fig. 4). The rocket engine was fired vertically upward with the rocket nozzle centerline located near the test chamber vertical centerline. The thrust chamber and nozzle were constructed in a stainless steel heat-sink configuration, duplicating the internal geometry of the prototype engine.

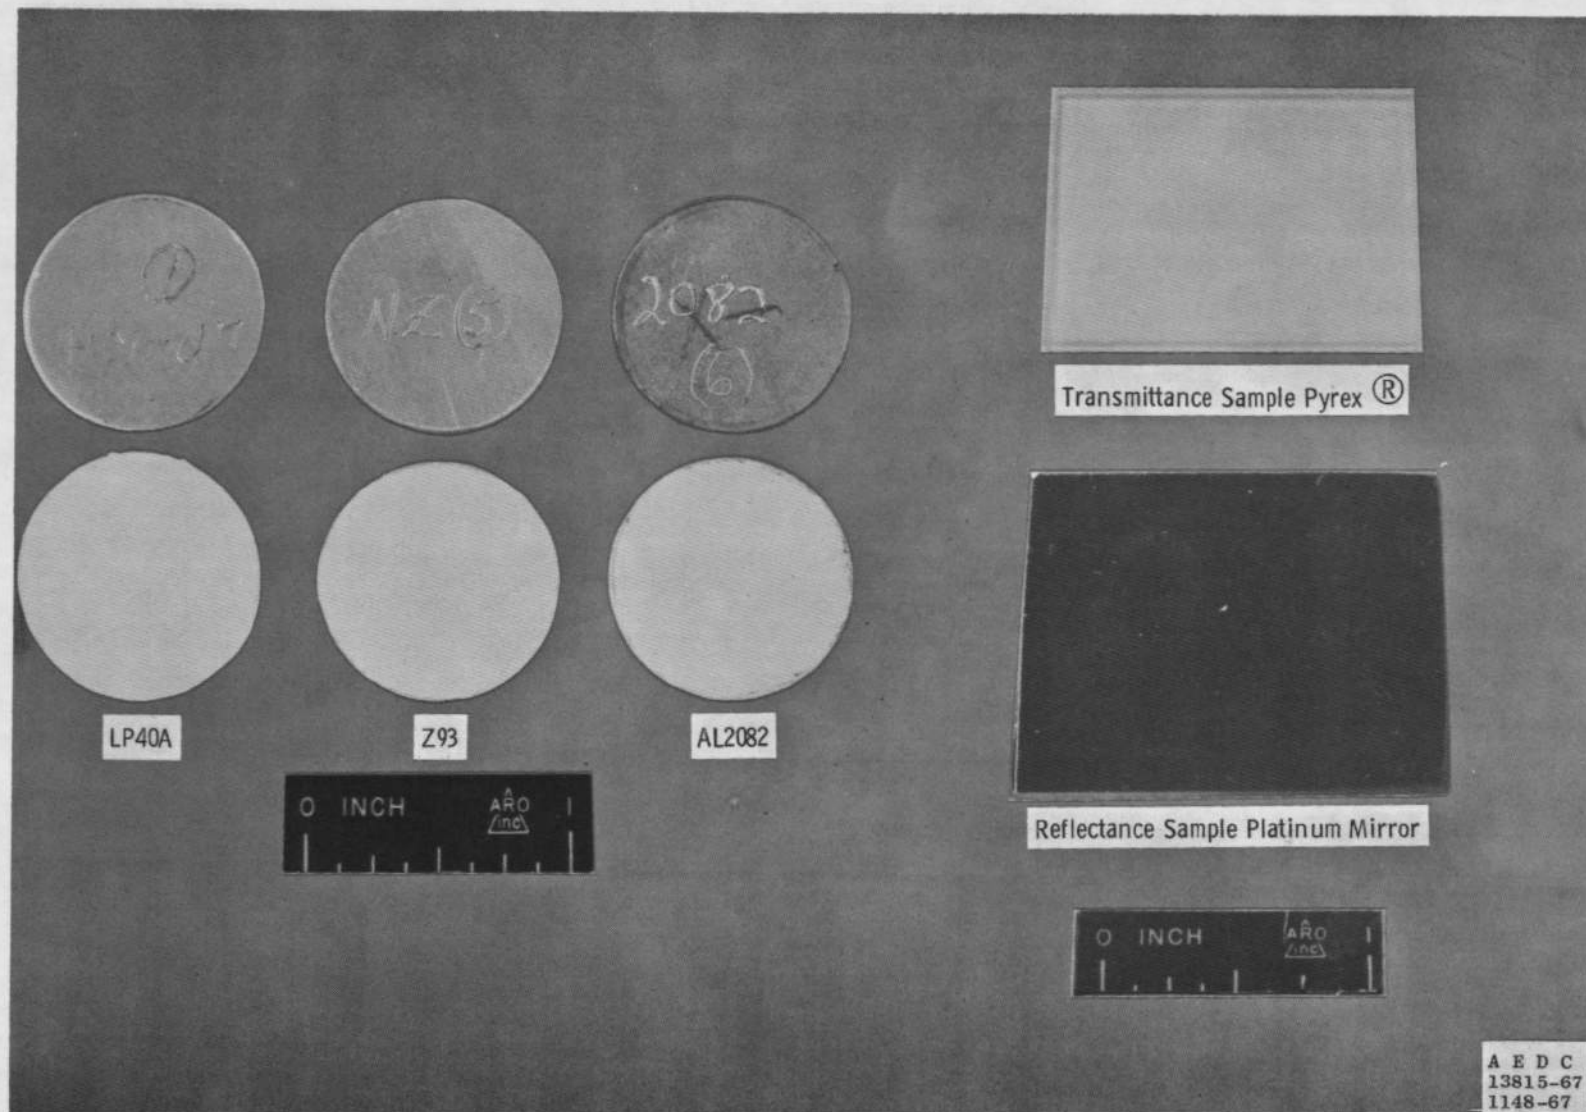
Fig. 5 Unexposed Surface Samples

The test samples (Fig. 5) used in this test were three types of thermal control coatings, platinum mirrors, Pyrex slides, and silica disks. The

surface areas of the test samples were between 0.7 and 1.7 in.<sup>2</sup>. The transmittance of silica and Pyrex was measured before and after exposure to the rocket exhaust. Reflectance measurements of the thermal control coating and platinum mirror surfaces were made before and after exposure to the rocket exhaust. The composition of the thermal control coatings are given in Table I, Appendix II. The three coatings are designated as AL2082, Ceramic Enamel, LP40A, and Z93.

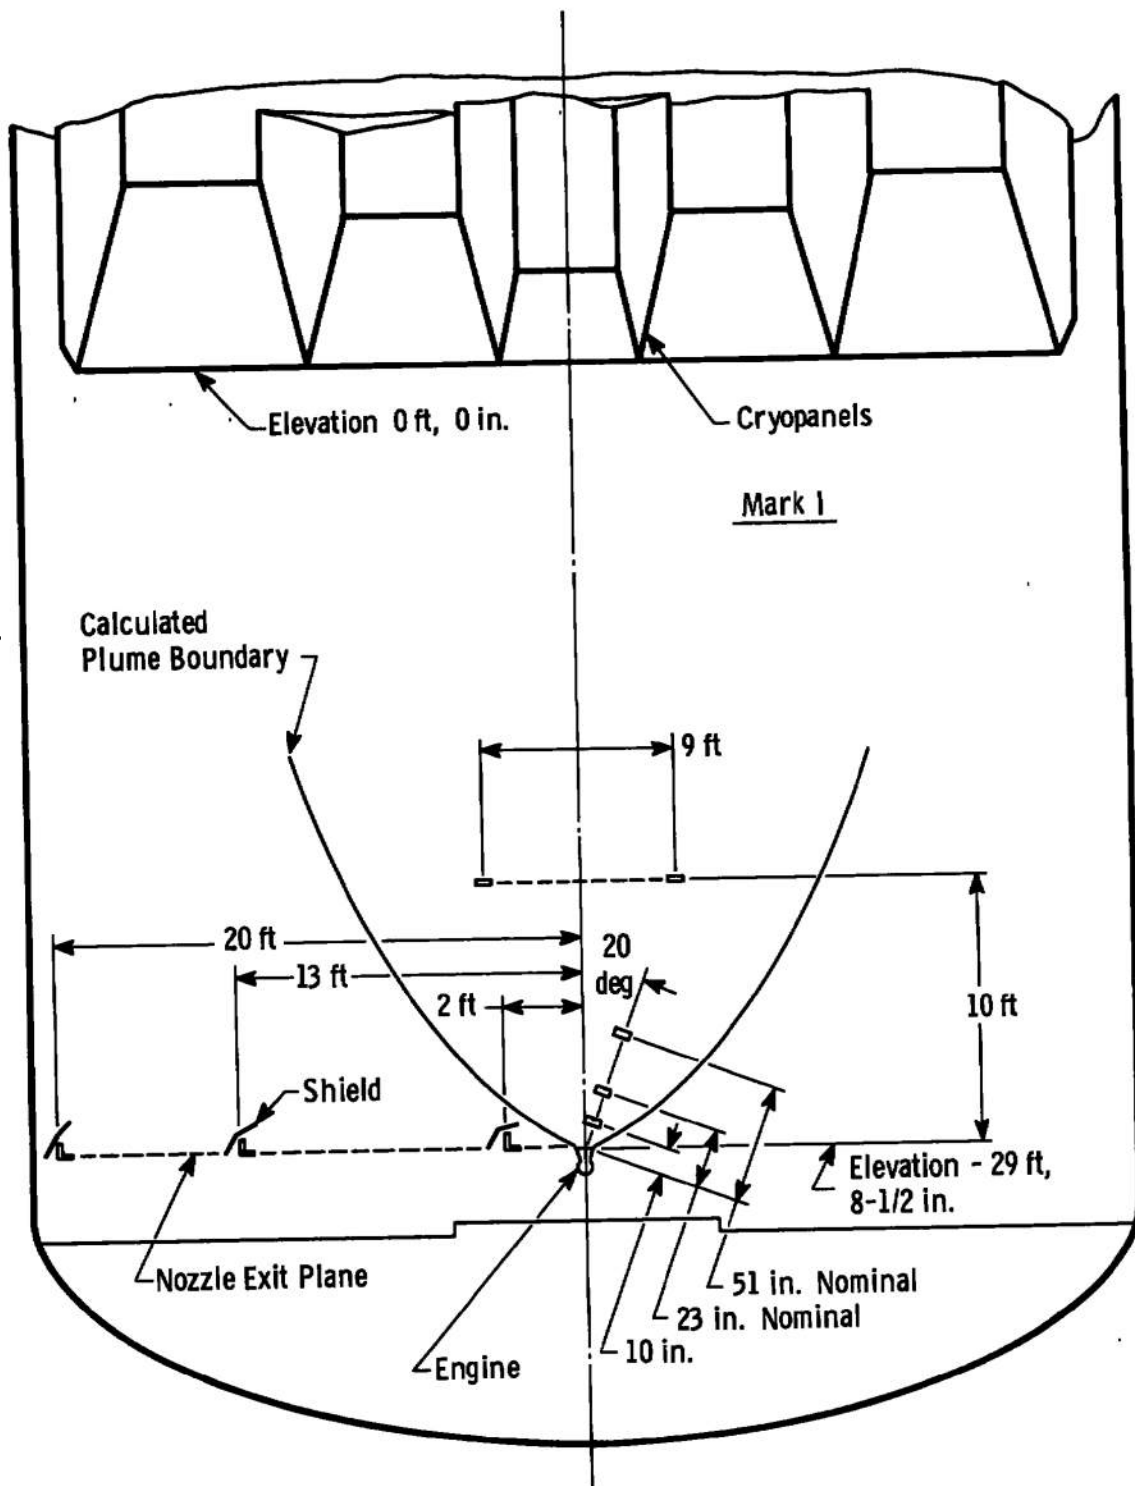
Fig. 6 Sample Location Schematic

Surface samples were mounted at various distances from the engine nozzle exit. The sample locations and their relation to the exhaust plume are shown in Fig. 6. The superimposed plume boundary was calculated for stable engine operation at the test altitude. The samples were enclosed in an "optically tight" temperature controlled container shown in Fig. 7. This container prevented direct impingement from any oil backstreaming or dripping from cryopanel. The sample container was remotely opened for the duration of the engine firing. The thermal control sample surfaces were mounted parallel to streamlines emanating from the engine exit, and the mirror and glass sample surfaces were mounted perpendicular to the streamlines. Samples and a deposit thickness monitor located 10 ft from the engine exhaust were mounted from a traversing beam. Before most engine firings, the traversing beam and the attached samples or instrumentation were relocated. Mirrors and glass samples were located in the nozzle exit plane during the pulse operation. The samples were mounted parallel and perpendicular to the nozzle exit plane at three locations shown in Fig. 6. The samples were protected by a shield from drippings of the cryopanel.

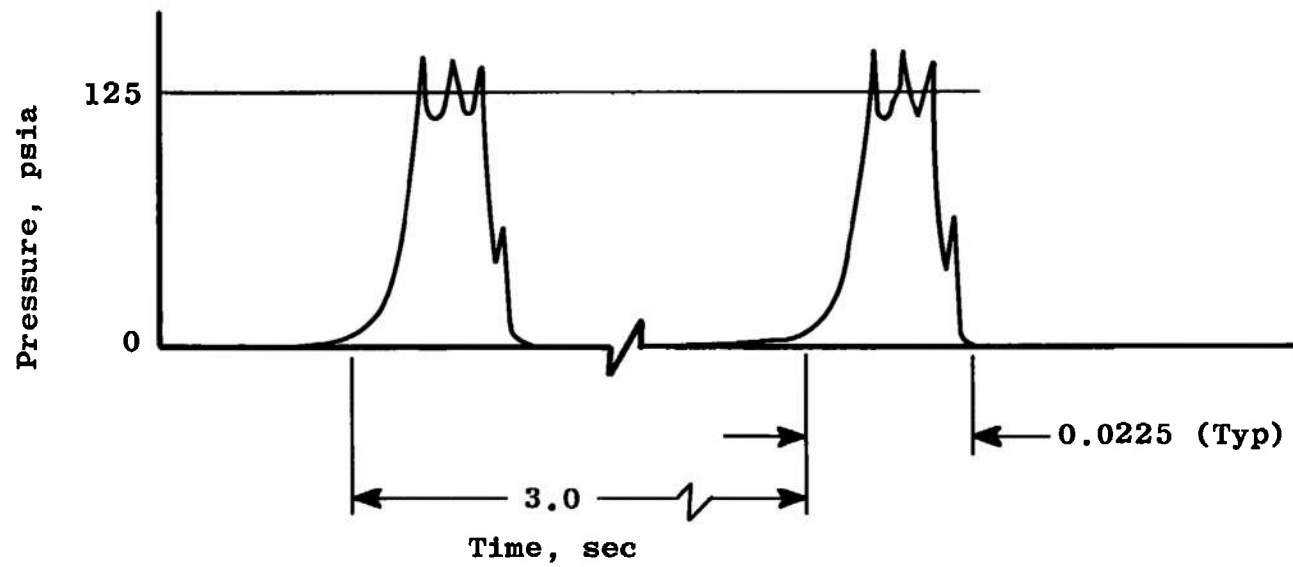
Fig. 9 Rocket Engine Combustion Chamber Pressure for a Typical Pulse Firing

The sample containers were not closed between the individual firings of pulse operation. A typical engine combustion chamber pressure during pulse firing is given in Fig. 9.

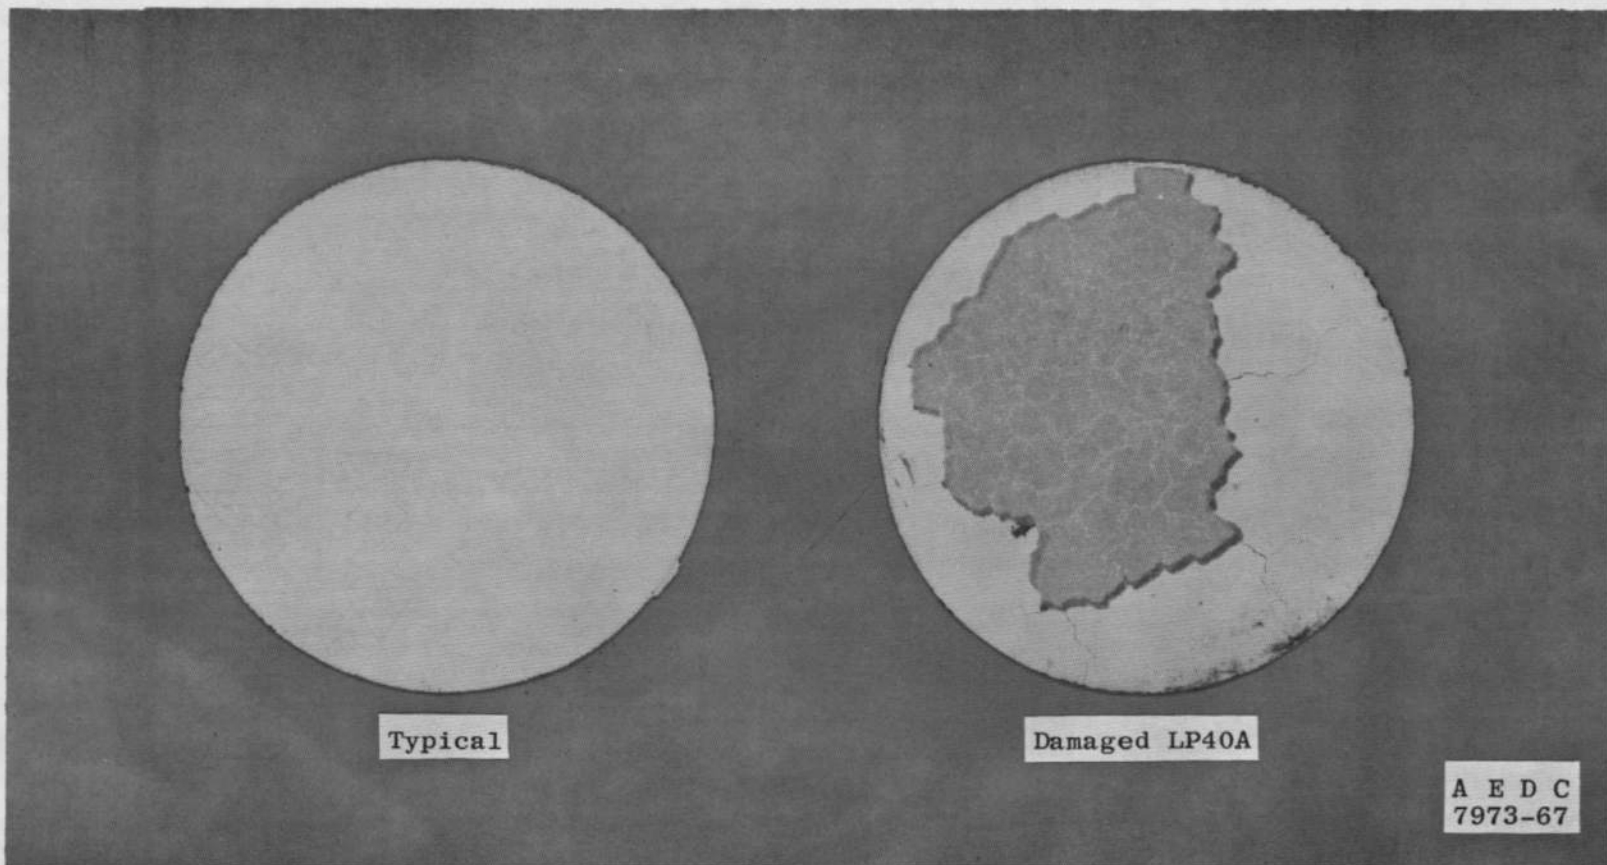
Fig. 10 Exposed Thermal Control Coatings

Normally there were no visible changes on the thermal control coating surfaces as a result of contamination. A typical exposed surface

and a damaged LP40A surface are shown in Fig. 10. The LP40A sample was located 51 in. from the engine exit when damaged. The damage appears to be a bond failure of the brittle material. Since the LP40A surface was not damaged at the closer distances of 10 and 23.3 in., the bond failure could be viewed as an exception not caused by exposure to the rocket exhaust.

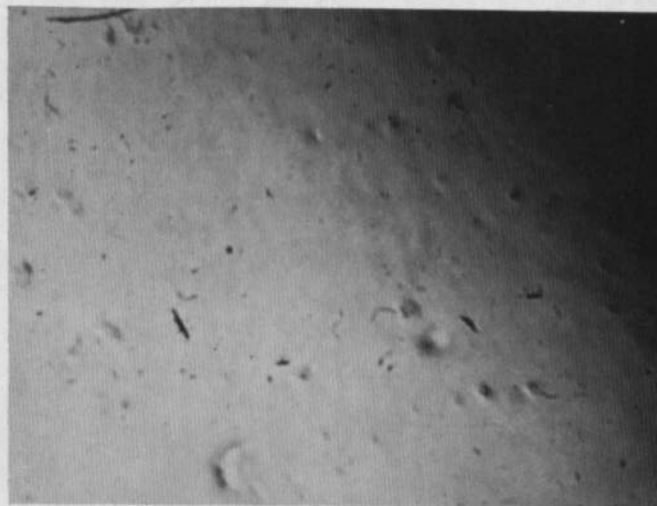
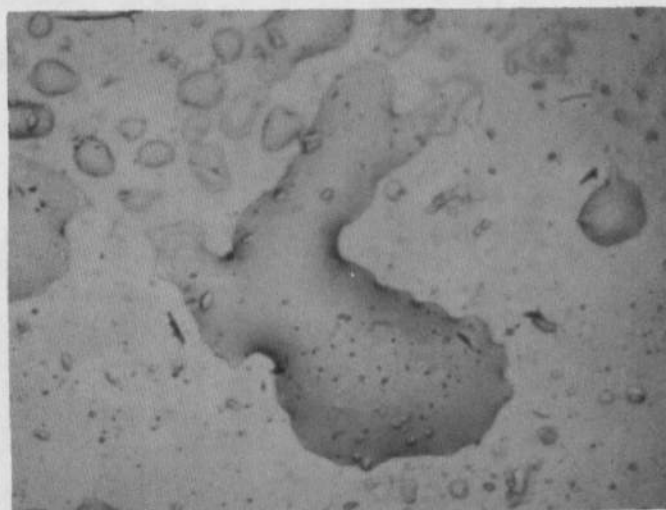
Fig. 11 Photomicrograph of Contamination Film

Colorless contaminants were visible on the exposed surfaces of the mirrors and glass slides. The contamination was uniformly distributed and did not obstruct vision through the glass samples. Photomicrographs of a mirror surface before and after exposure are shown in Fig. 11. The contamination film consisted of a series of droplets or beads.

Clean Surface - 510X

Contaminated Surface - 510X

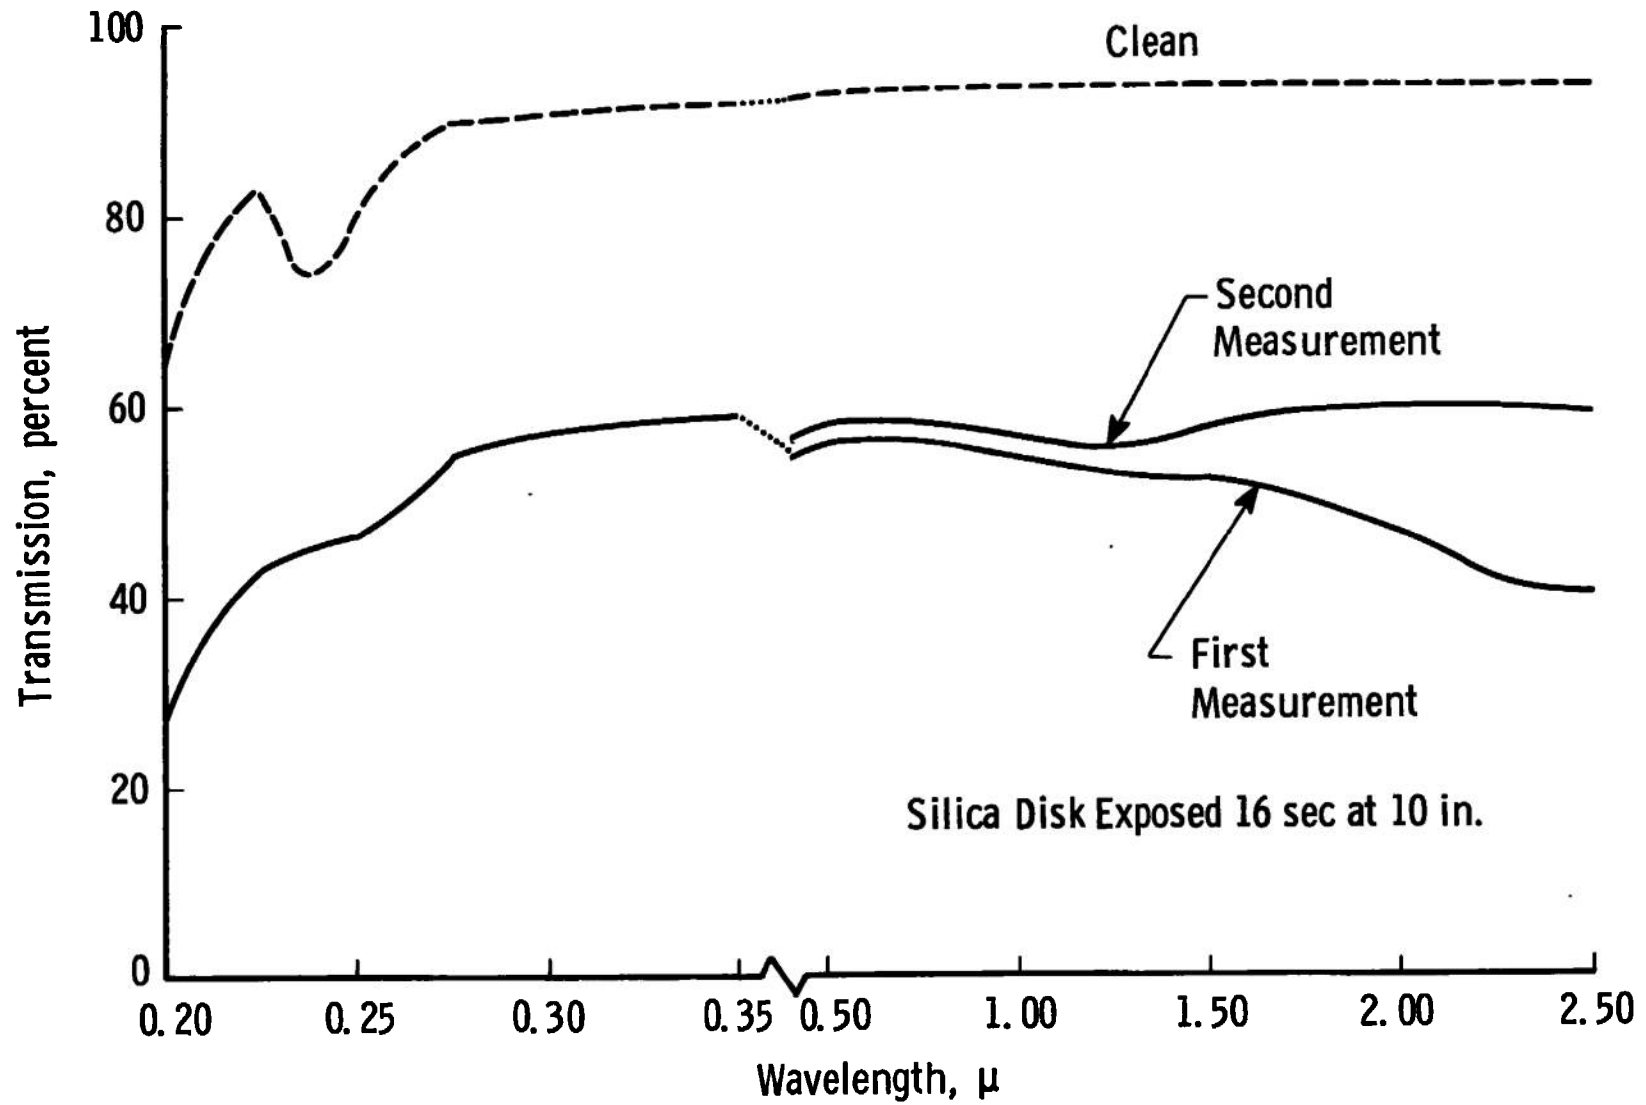
Fig. 12 Transmission Change of Volatile Deposition

The contaminants deposited on the samples appeared to be stable. An exception was the deposit on one silica disk which changed while the transmittance was being measured. The data from two successive analyses varied as much as 30 percent and are presented in Fig. 12 without explanation.

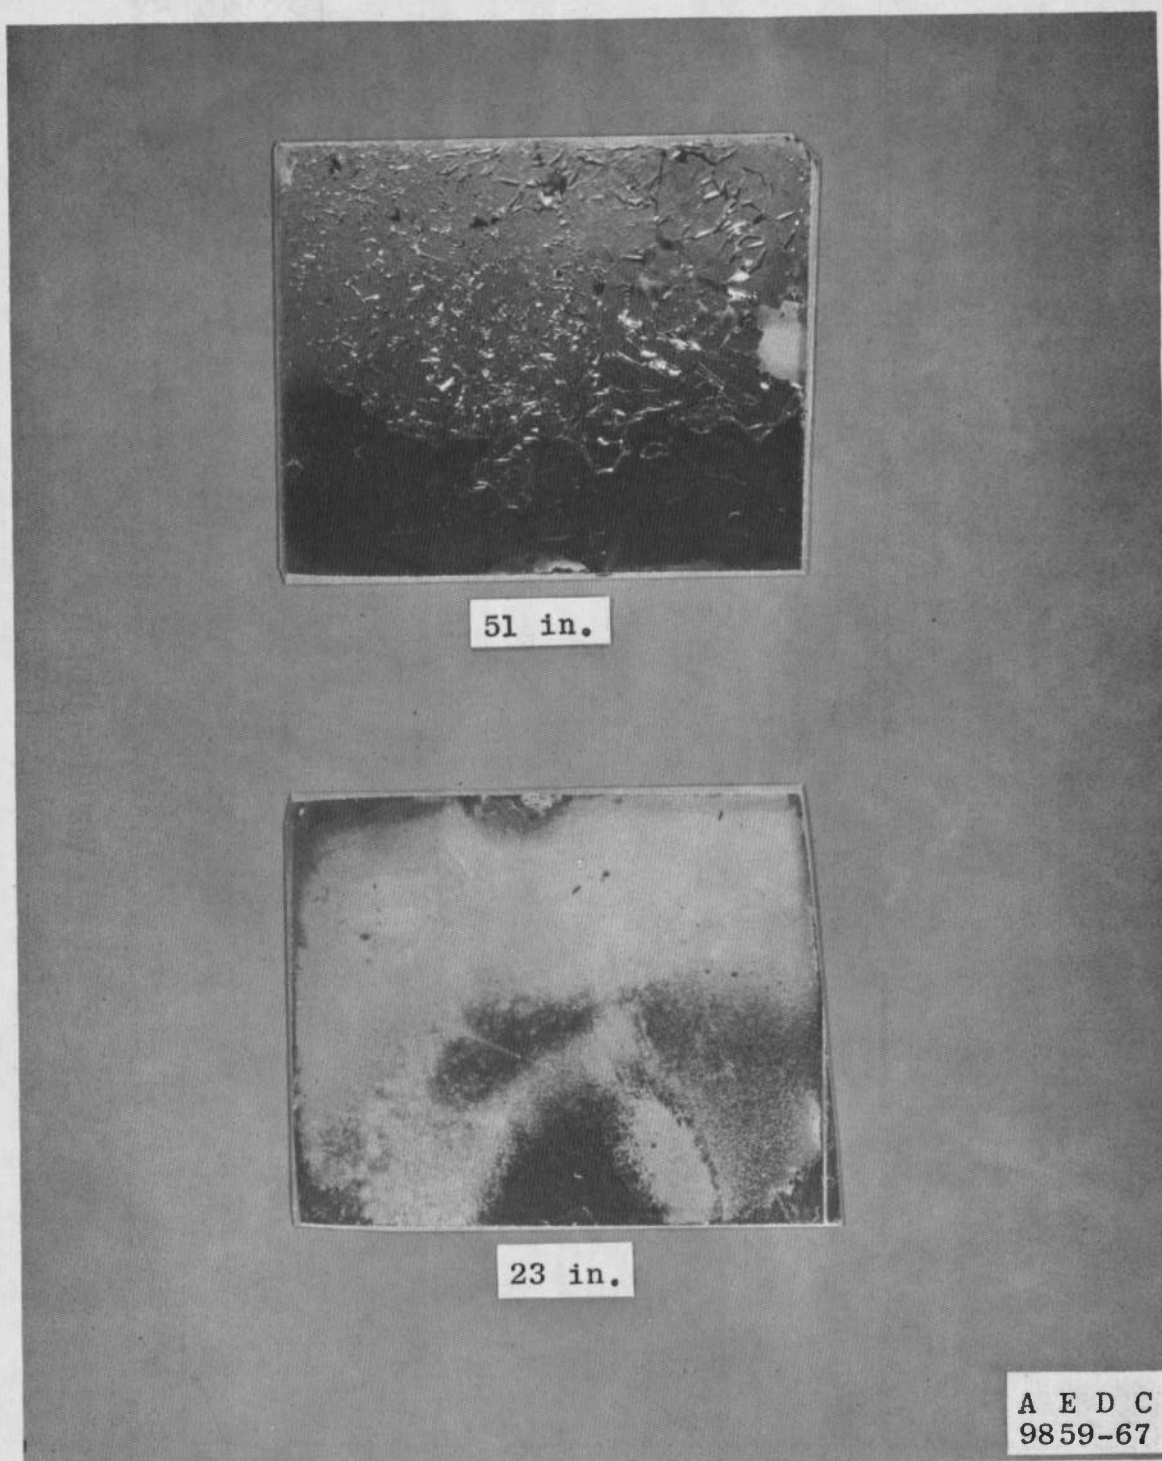
Fig. 13 Platinum Mirror Surface Damage - Pulse Exposure

During pulse firings, the surfaces of the mirrors (Fig. 13), at 23 and 51 in. in front of the engine exit, were damaged. The mirror surface at 23 in. had over 65 percent of its area stripped, and the remaining portion was not a good reflector. About 10 percent of the mirror surface at 51 in. was stripped, and 60 percent of the surface was cracked.

The mirrors exposed to pulse firings and located in front of the nozzle exit suffered surface damage. The reflectance surfaces (Fig. 13) were ruined at these locations. The damage was more severe for the sample closer to the engine exit. Based on experience from this test, damage to reflective surfaces similarly exposed would be highly probable in actual flight.

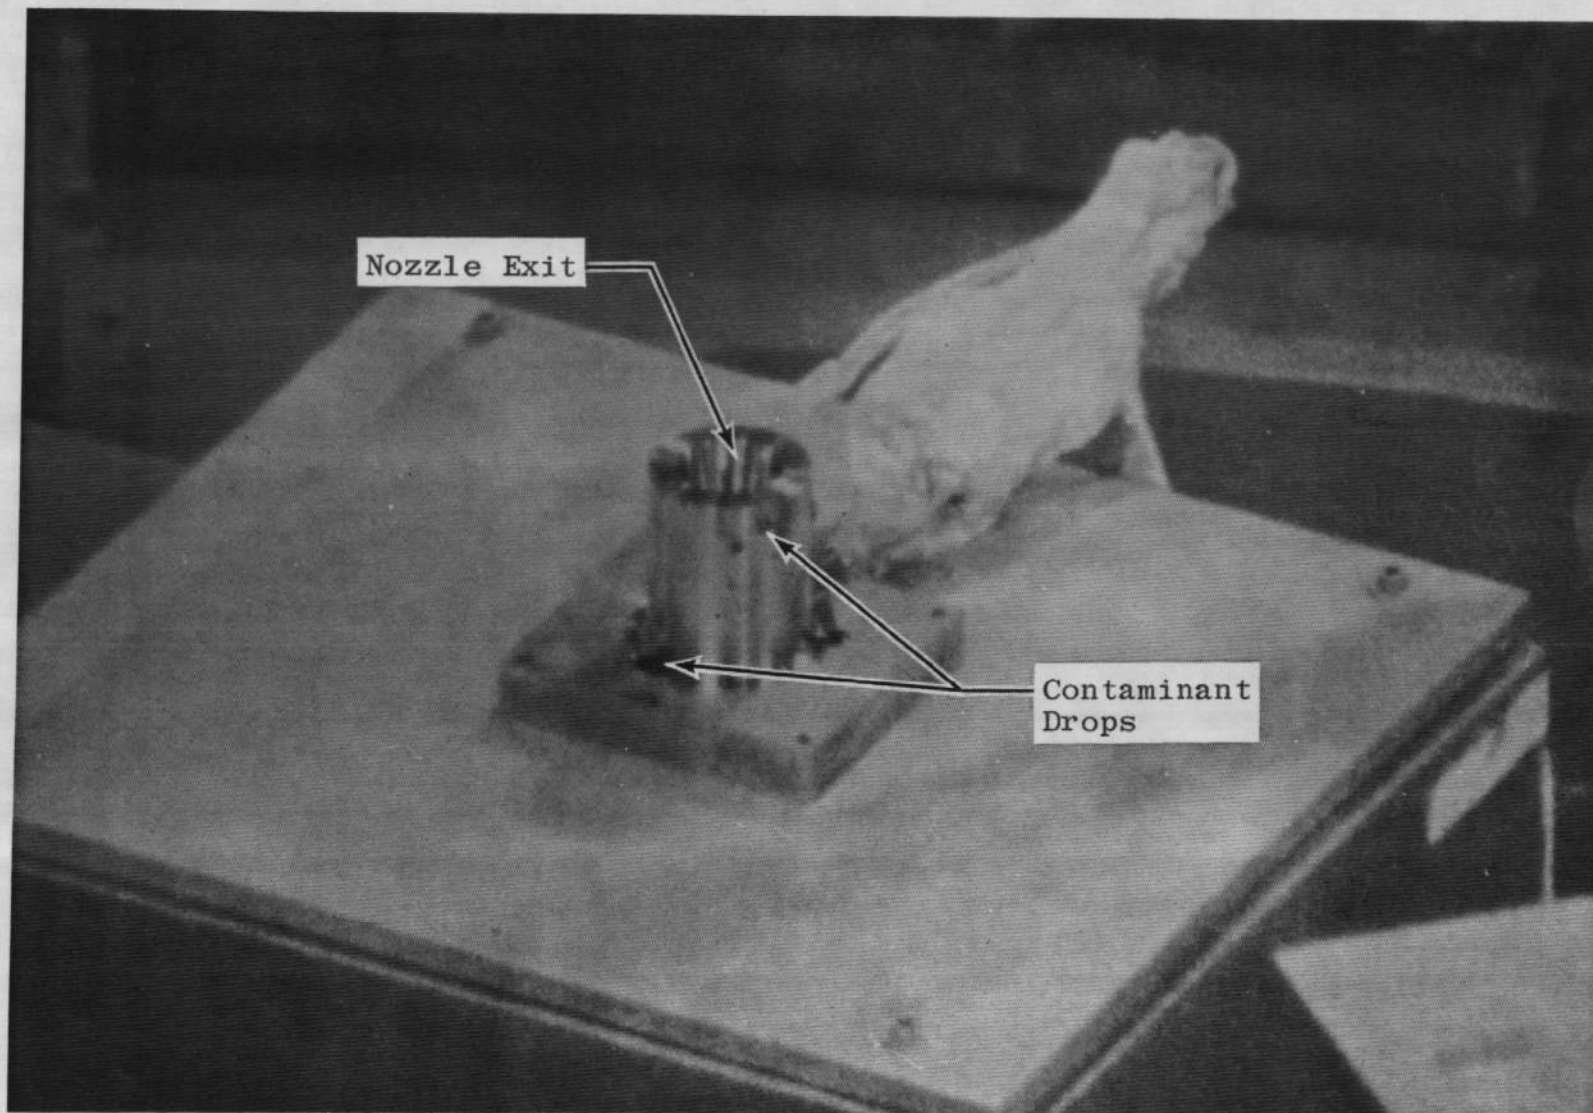
Fig. 14 Contamination during Pulse Engine Operation

During pulse operation, contaminants were deposited at the nozzle exit in sufficient quantity to spill over the side of the nozzle as evident in Fig. 14. This deposition, a brown viscous liquid, could explain the contamination observed outside the exhaust plume. The contaminants at the nozzle exit appeared to shake or jump when the engine fired. Therefore the deposit could have been blown outside the plume. The deposit at the nozzle exit appeared to scintillate. This may be explained by

reflection of photographic lights or by explosions. Explosions could blast the contaminants outside the exhaust plume.

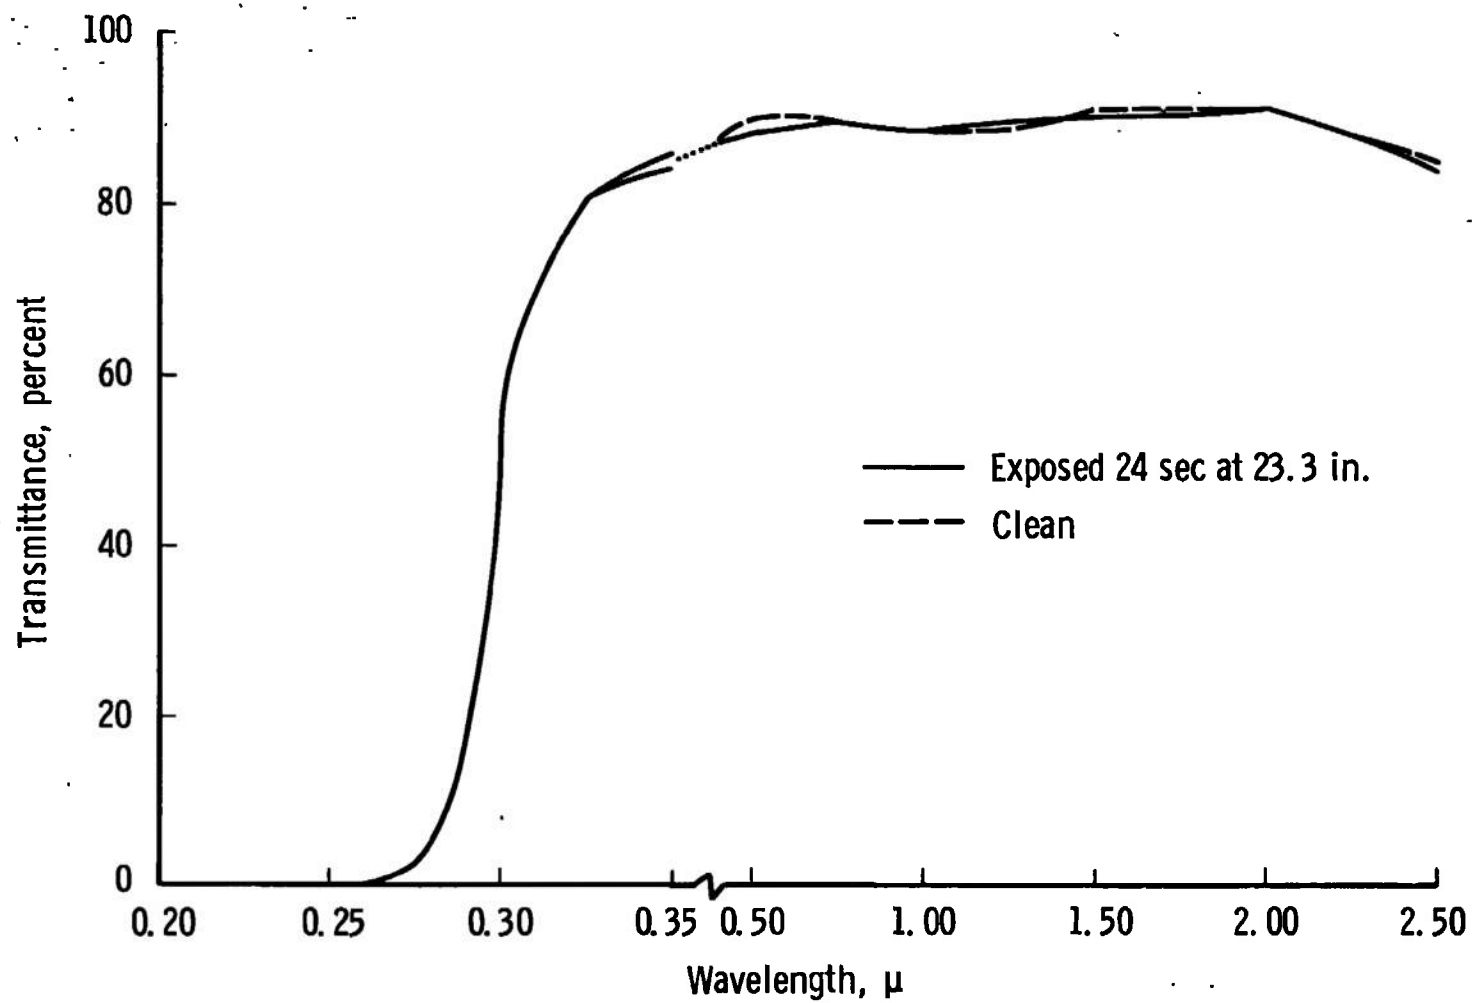
Fig. 15 Pyrex Transmission - Typical Long Duration Exposure

Pyrex slides were exposed for the combinations of longer duration firings and the various locations listed in Table II. The transmittance changes during these exposures were very small, varying from the measured clean values by no more than 7 percent. A typical transmittance change for these exposures is shown in Fig. 15.
